# West Roofing Systems Inc.

## Medical Facilities

This Illinois Hospital had 7,400 square feet of scalloped concrete roof deck with an existing smooth surface modified bitumen. Specifications called for removal of approximately 50% of the existing roof system that was saturated and installation of 3" SPF with 20 mils of silicone coating and granules.

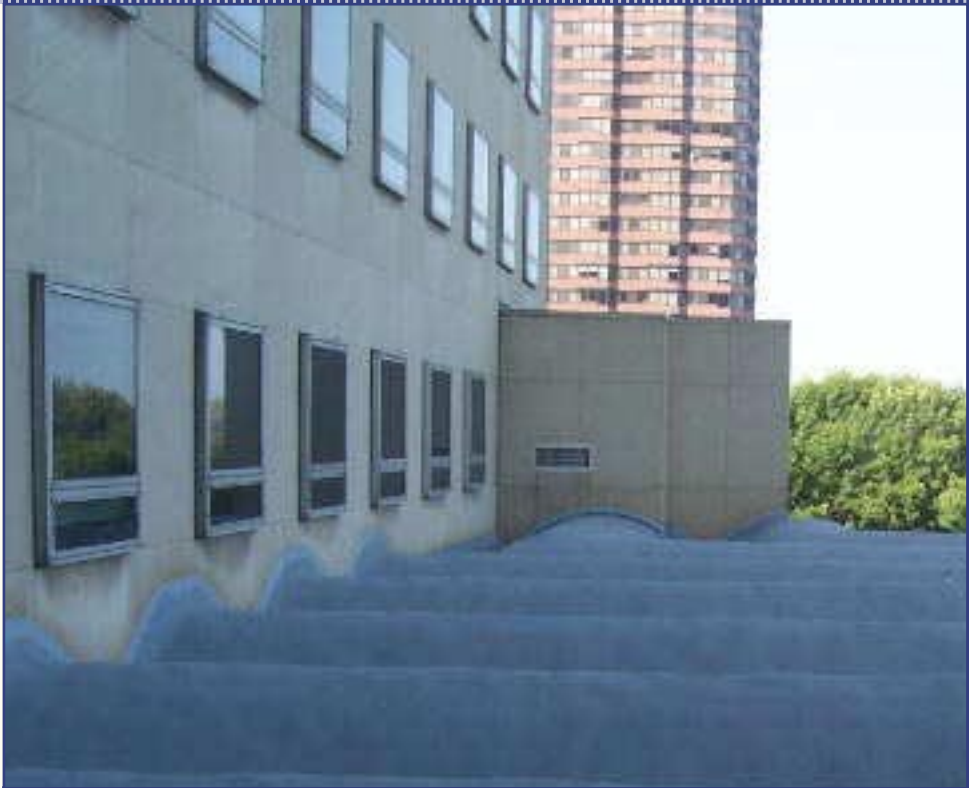
This scalloped hospital roof received a 10 year manufacturers warranty.

The 3" of SPF provides an approximate R-value of 20, and the fluid applied self-flashing foam fit perfectly for the roof configuration.

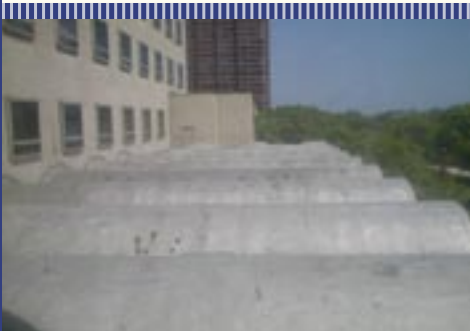
"Before" picture of scalloped roof.

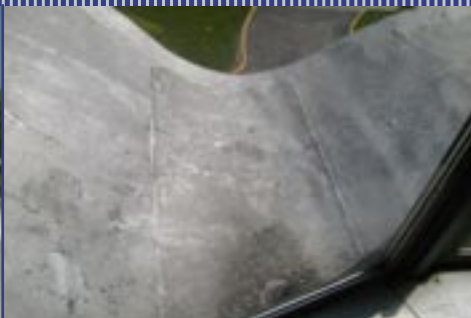
"Before" picture of aged valley in roof.

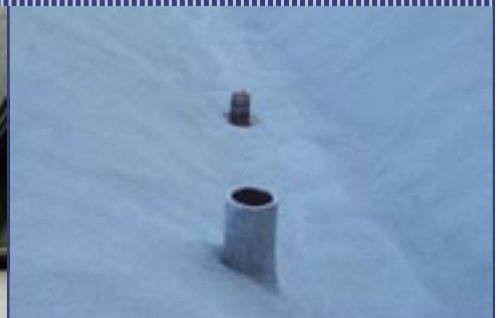
"After" picture of drain and vent stack in valley.
