West Roofing Systems Inc.

Schools and Churches

This central Ohio church had persistent leaks as well as structural damages with a 30 year old spray polyurethane roof. Original scope included recoating 10,000 sq. ft. of SPF with 25 mils of acrylic and replacing the deteriorated fascia board.

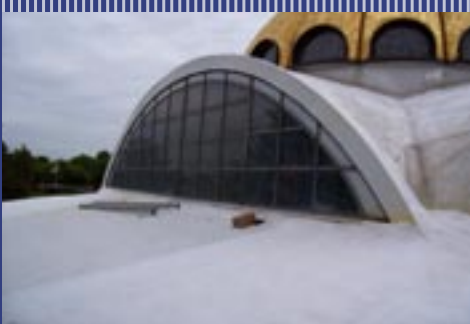
"Before" picture of 30 year old SPF roof.

A blue coating was installed to restore the roof to its original color. Citadel's sincore panels were used to replace the fascia so the leak problem would not occur again. Neogard's Acrylithane C was used to coat the panels and aluminum framing of the window system.

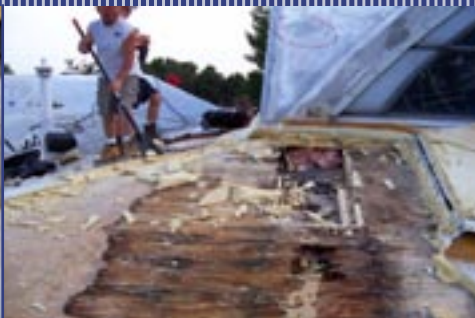
Tear off of deteriorated roofing material.

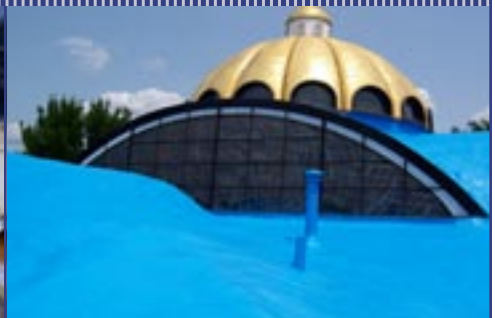
Completed Project.
